## Retrofit Solutions Designed to Minimize Cost of Warranty Repairs

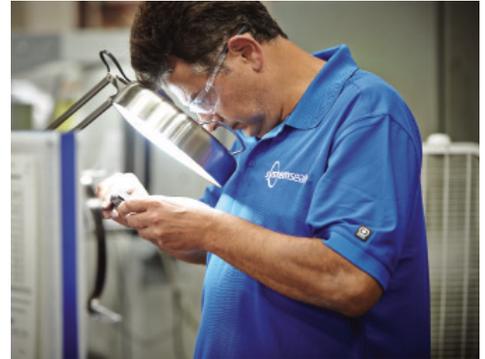
System Seals engineers first reviewed the wheel assembly to fully understand the application and then analyzed the current under-performing seal. An investigation of the current seal revealed a small, but unnecessary heel under the sealing lip, which was likely added to help in the molding of the seal. An FEA analysis showed that this heel was unintentionally contacting the internal assembly when under compression and deflection.

The deformation of the seal lip increased the potential for contamination. It also increased friction, resulting in premature seal wear. System Seals was able to determine the root cause of failure, which informed their engineers on how to design a replacement.

After reviewing all of their findings, System Seals designed a new double lip seal, made from the abrasion resistant MP03 H-Polyurethane material. The result was a highly effective seal with 100% reliability that worked well past the manufacturer's warranty.
