Upgrading O-Rings In Dynamic Applications

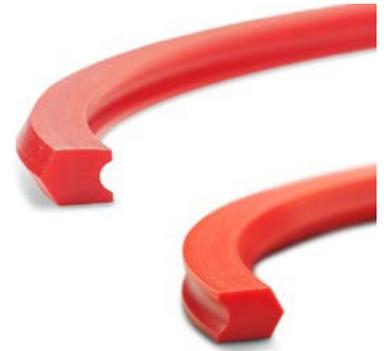
After a thorough examination of the failed seals, System Seals determined that there were two modes of failure. The first is that the dynamic O-rings were rolling when the rod stroked, thus allowing fluid bypass and ultimately breakage of the seal. The second failure mode was leakage past the static seals whenever the gland deflected to one side.

High temperature actuators for plastic processing equipment were experiencing warranty failures in the field due to poor sealing performance and lack of rod guidance.

The first upgrade was to replace the dynamic O-rings with System Seals profile types 161 and 261 in FKM. Utilizing the more robust profiles allowed us to prevent rolling, and reduce the number of seals from two O-rings down to one molded seal.

The grooves that were freed up were repurposed for guidance, where we specified the use of a custom size PTFE/Bz guide band. The inclusion of the guide bands prevented metal on metal contact, and eliminated the deflection that was causing leakage across the static seals.

System Seals replaced the dynamic O-rings with type 161 and 261 seal profiles, and retrofitted a redundant groove to provide much needed guidance.
